96 A6 Tailgate Vacuum Lock Leak Fix

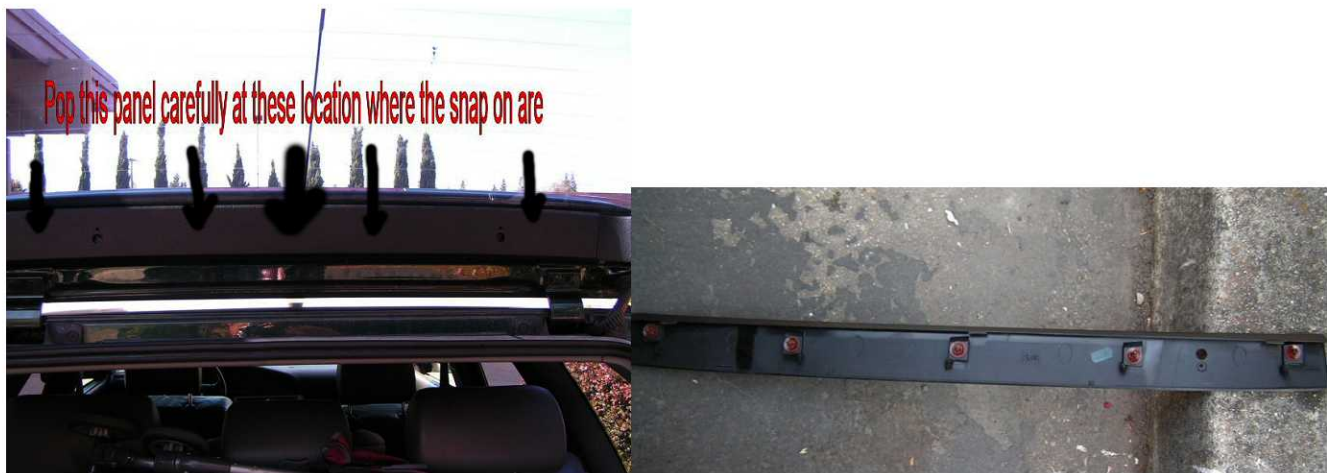
Remove top moldings:

*** Pry them out slowly and carefully, you need to put some force into it*****

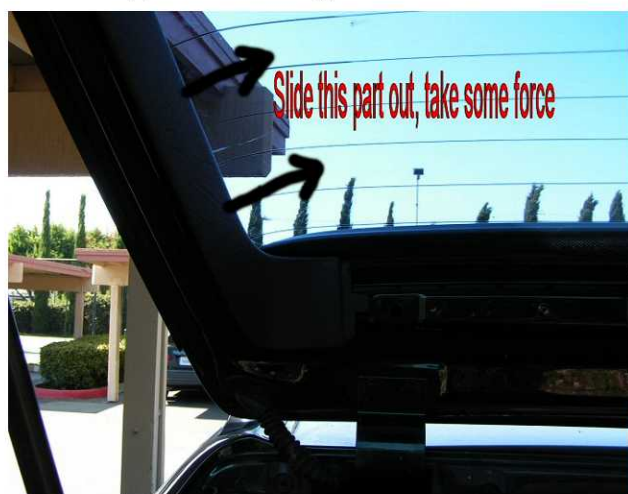
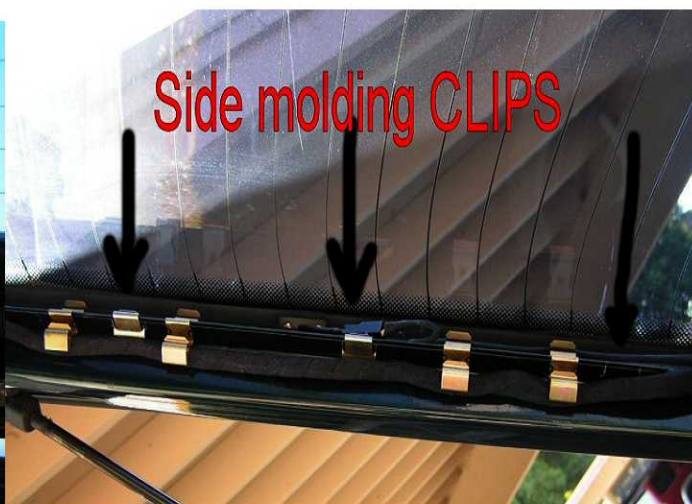
Removing Side moldings:

***** Pull these two sidemoldings out toward inside direction, wiggle and it does need some force.

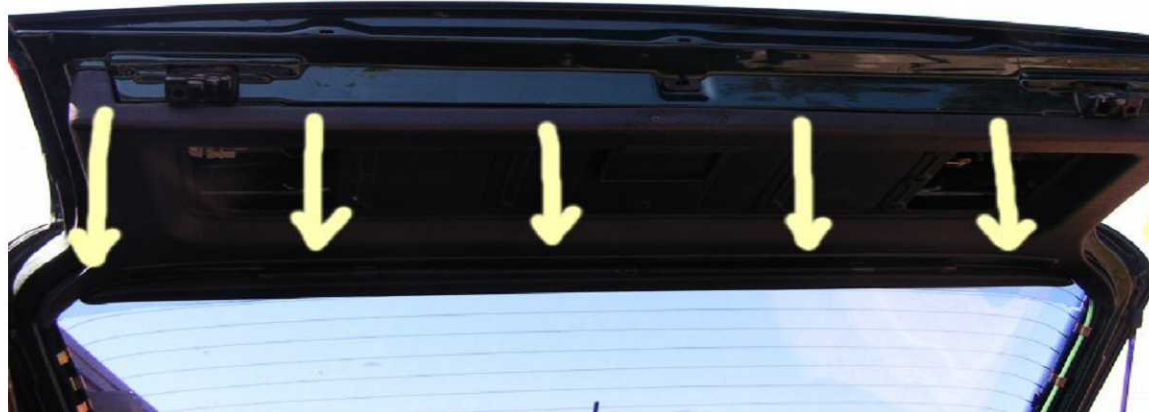
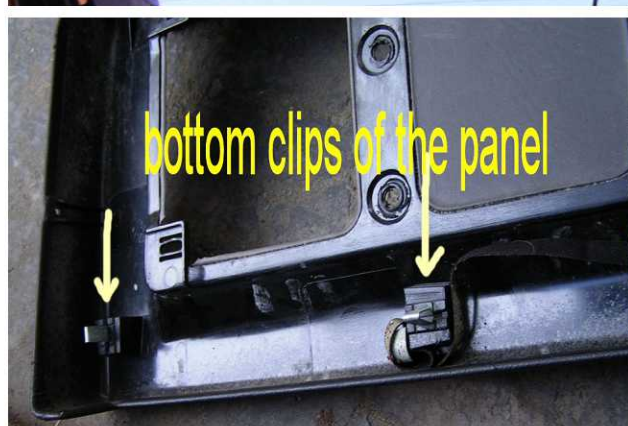
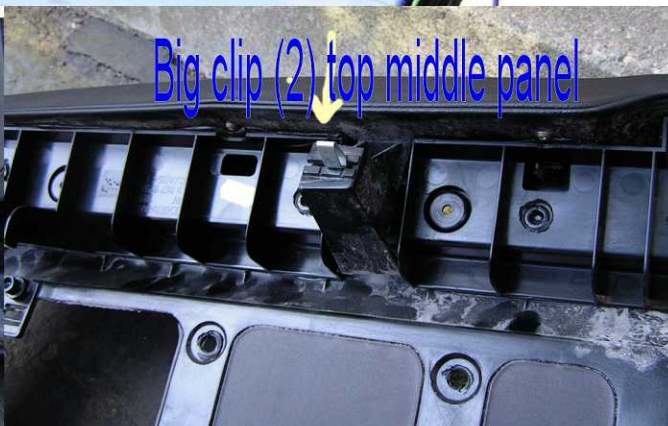
Remove main panel:

Pull panel down and out of the snap-on pins slowly and carefully

*When removing middle clips, be careful not to break it. Use a long screw driver to pry up***
* SLIDE THE PANEL UPWARD and TAKE IT OUT.

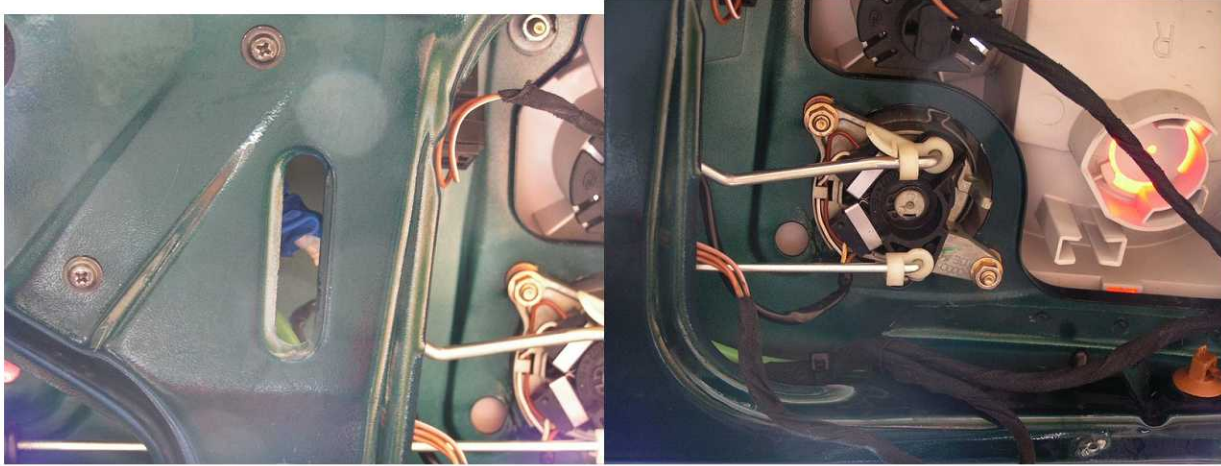
Removing the lock vacuum unit:

The vacuum unit is on the right side when the gate is up, remove the 2 screws and unhook the rod and slide it out.

***** Carefully remove the lock on the vacuum hose connector and it will slide right out *****
I used 2 little screw drivers on each side and pry it out simultaneously.

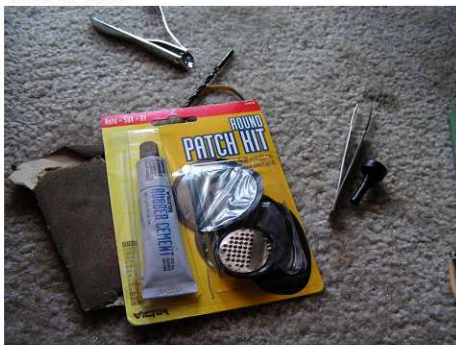
The FIX:

When you start to hear the leaking vacuum sound in the tailgate lock area and it takes time for it to lock or unlock, you have a crack on the vacuum boot and it will get bigger and one day it doesn't lock or unlock any more. If you go to the dealer, they will tell you that they only sell the whole unit for \$175 as in my dealer (July, 2006). Well, even I have the money to buy the unit, but I'm not going to pay \$175 for the flimsy rubber boot, I tried to fix it and I think this way worked for me because by the time this procedure is written, it's been working for over a week with hundreds actuations.

Rubber cement and balloons. Use medium balloons with openings are just about the size of the boot. Apply rubber cement evenly all over the outside of the boot and then pull the cutout balloon over the boot as the picture shown, twist the balloon to make sure it's bond to the boot as much as possible.

When the cement and balloon settled to the boot, apply another coat of cement outside the balloon and pull 1 more balloon over the first one and twist the balloon again to make sure this balloon bonded to the first one. BE CAREFUL NOT TO SCRATCH or TEAR THE BALLOON due to LONG FINGER NAILS, CUT THEM before doing this (ask me how I know...☺)

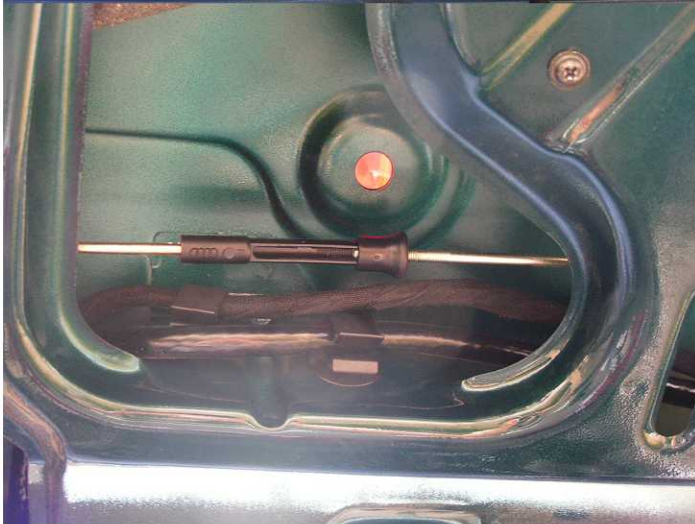
You can see the latch at the end of the rod, follow it to the handle.

Put the vacuum unit back in the car and test by lock and unlock door to see if it leaks, if you do it right, it will not leak, but the in/out movements will be less than before due to thicker layers of balloons. It may lock but will not unlock, I have to adjust the rod that releases/locks the mechanical lock. To adjust, release the rod from the holder, turn the rod counterclockwise if you want to extend the length and vice versa.

You can look under the handle and you can see if the handle starts to catch the lock mechanism, when it starts to catch, then turn a few more turns then retest the whole thing.
