1996 Audi A6 Wagon Armrest Fix

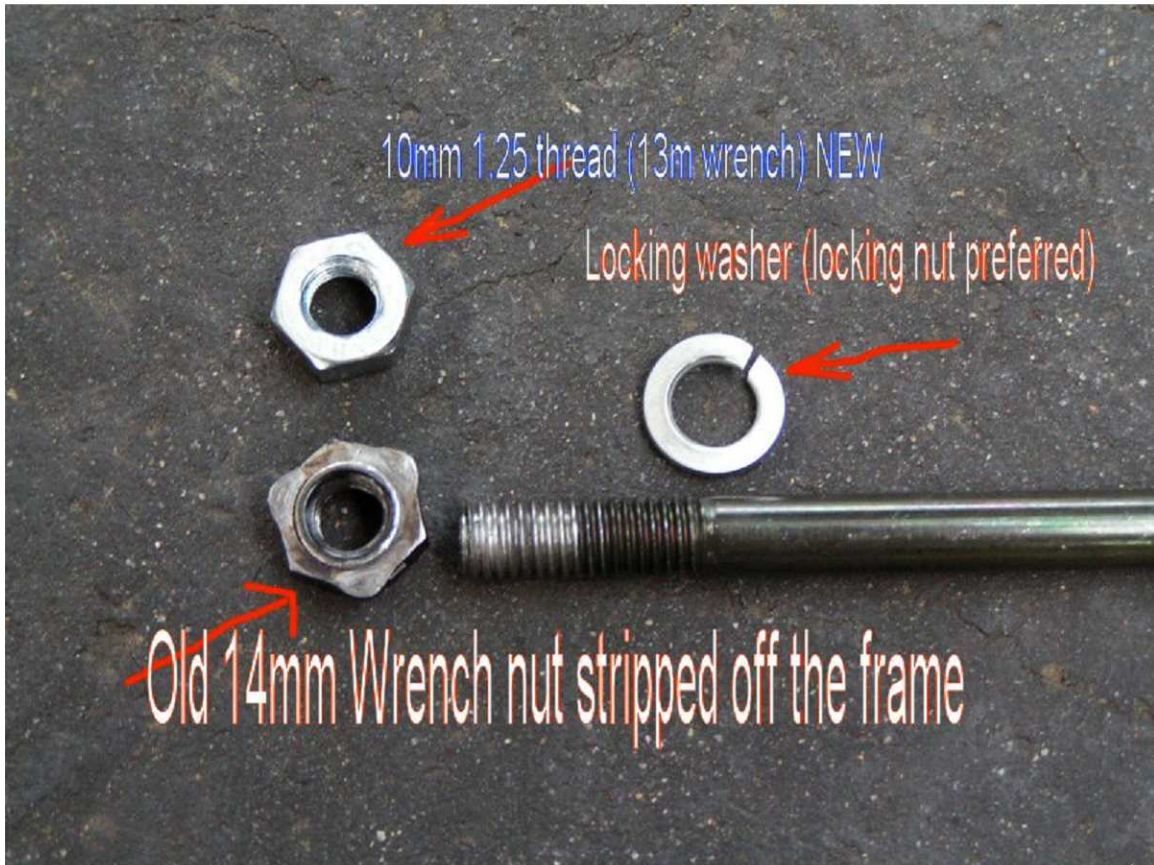
The armrest on the A6 is connected to the seat frame by a long bolt and a nut welded at the frame, when someone rest on the armrest too hard, this welded nut stripped, broke off the frame, the armrest is dangling and being loose and annoying. This is one way to fix it. I couldn't find the teathed locking 8mm nut, so I have to use the locking washer in place of this setup.

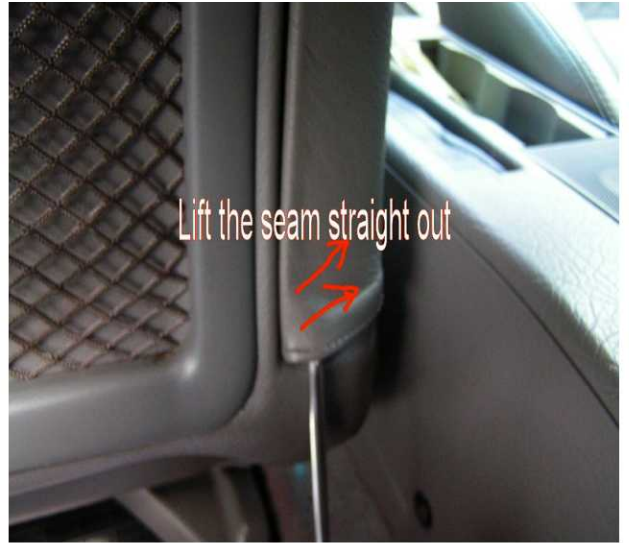
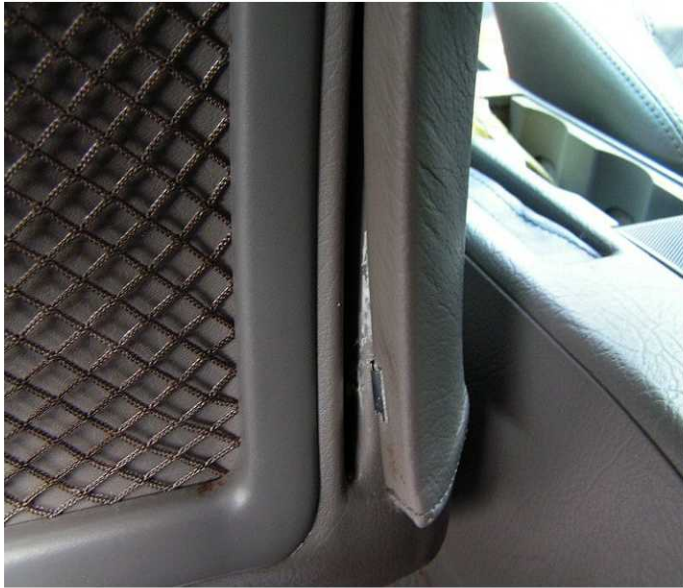
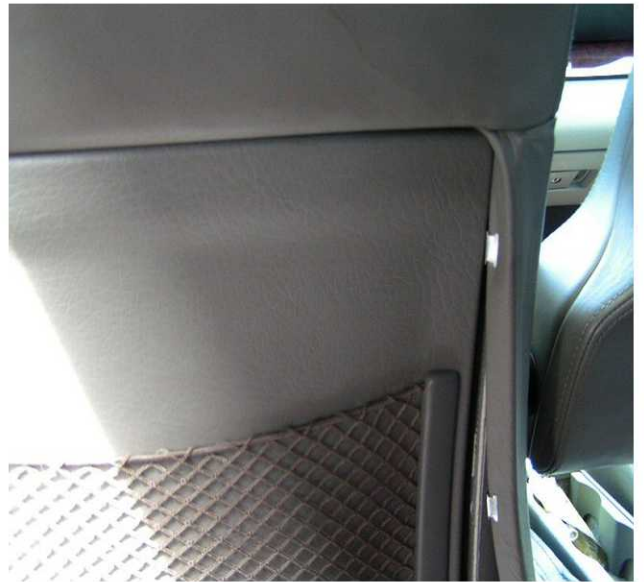
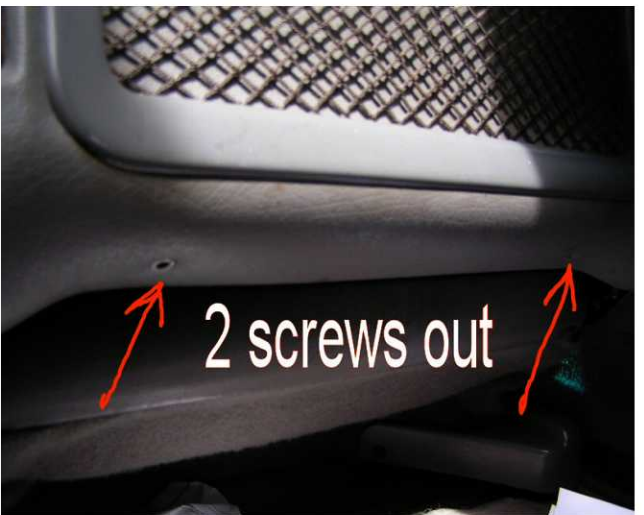
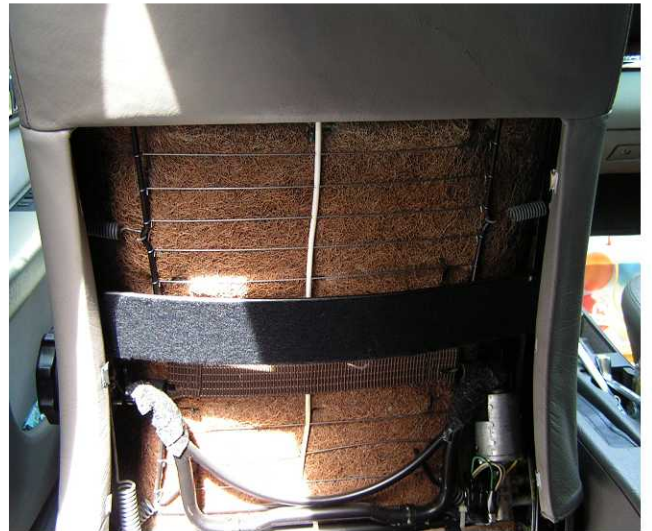
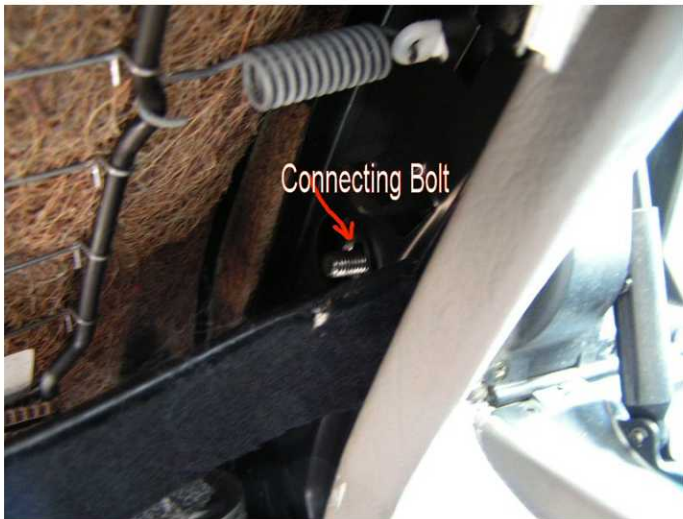
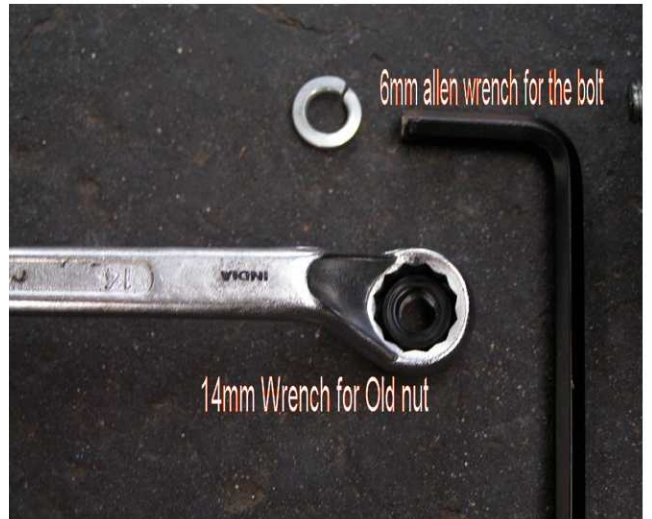
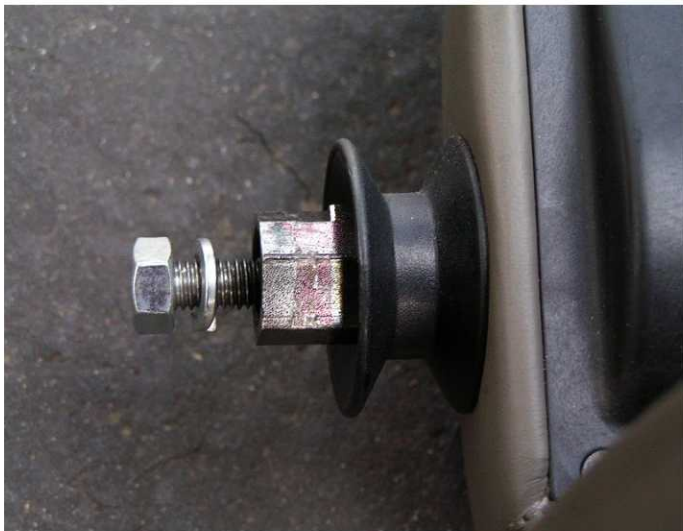
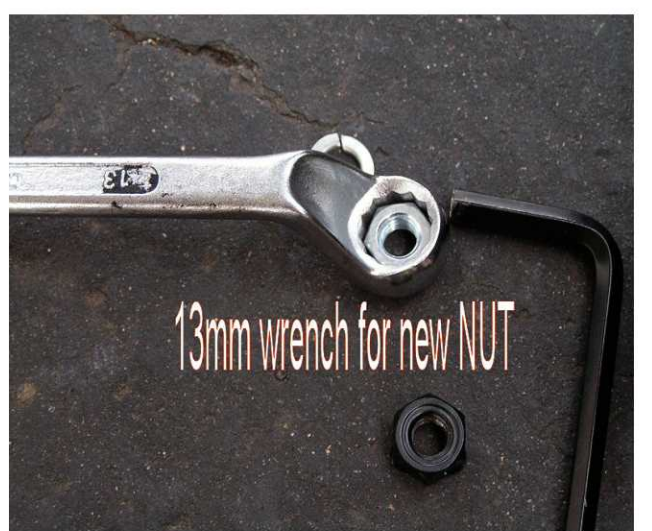
To remove the dangling armrest to replace the nut & locking washer:

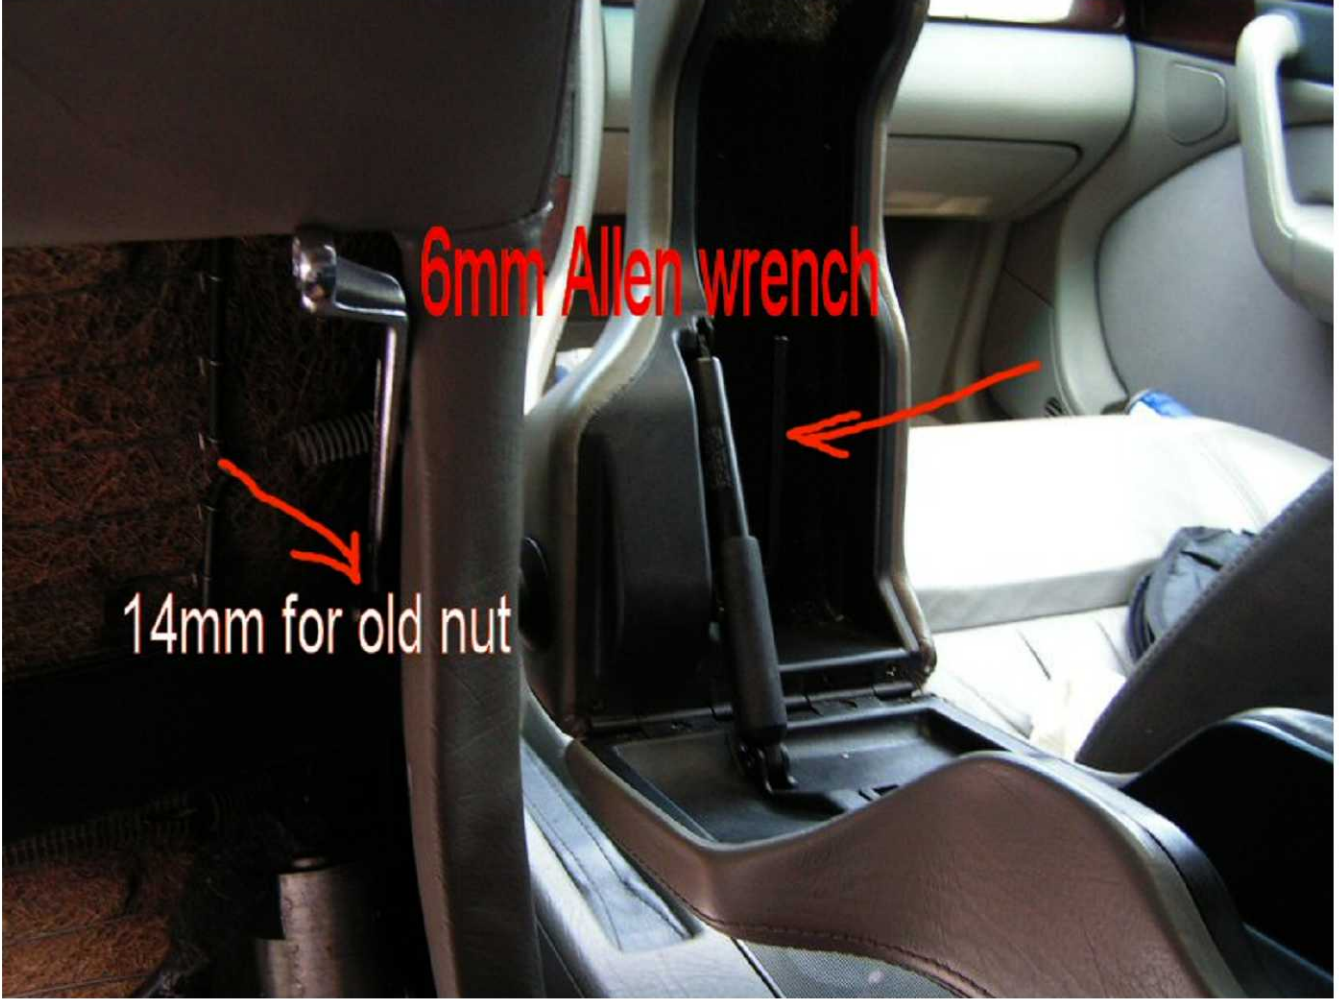
6mm Allen wrench

14mm for old nut

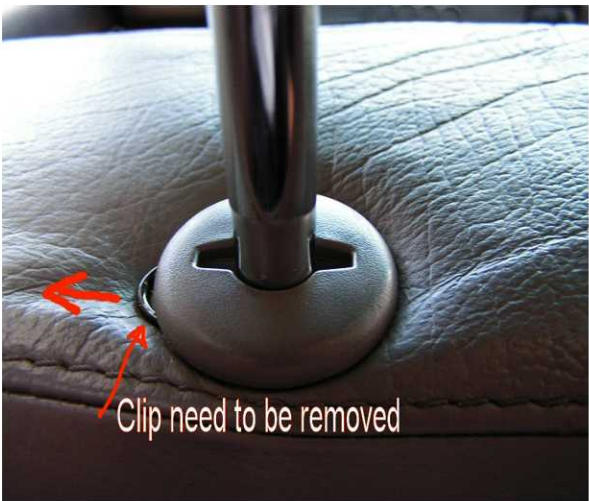
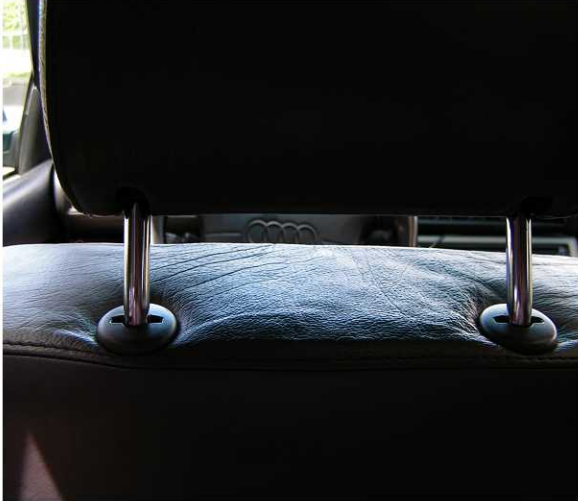
To remove the head rest if you need:
